Broken Rear Shackle Bolt

by Tom Endy 2024

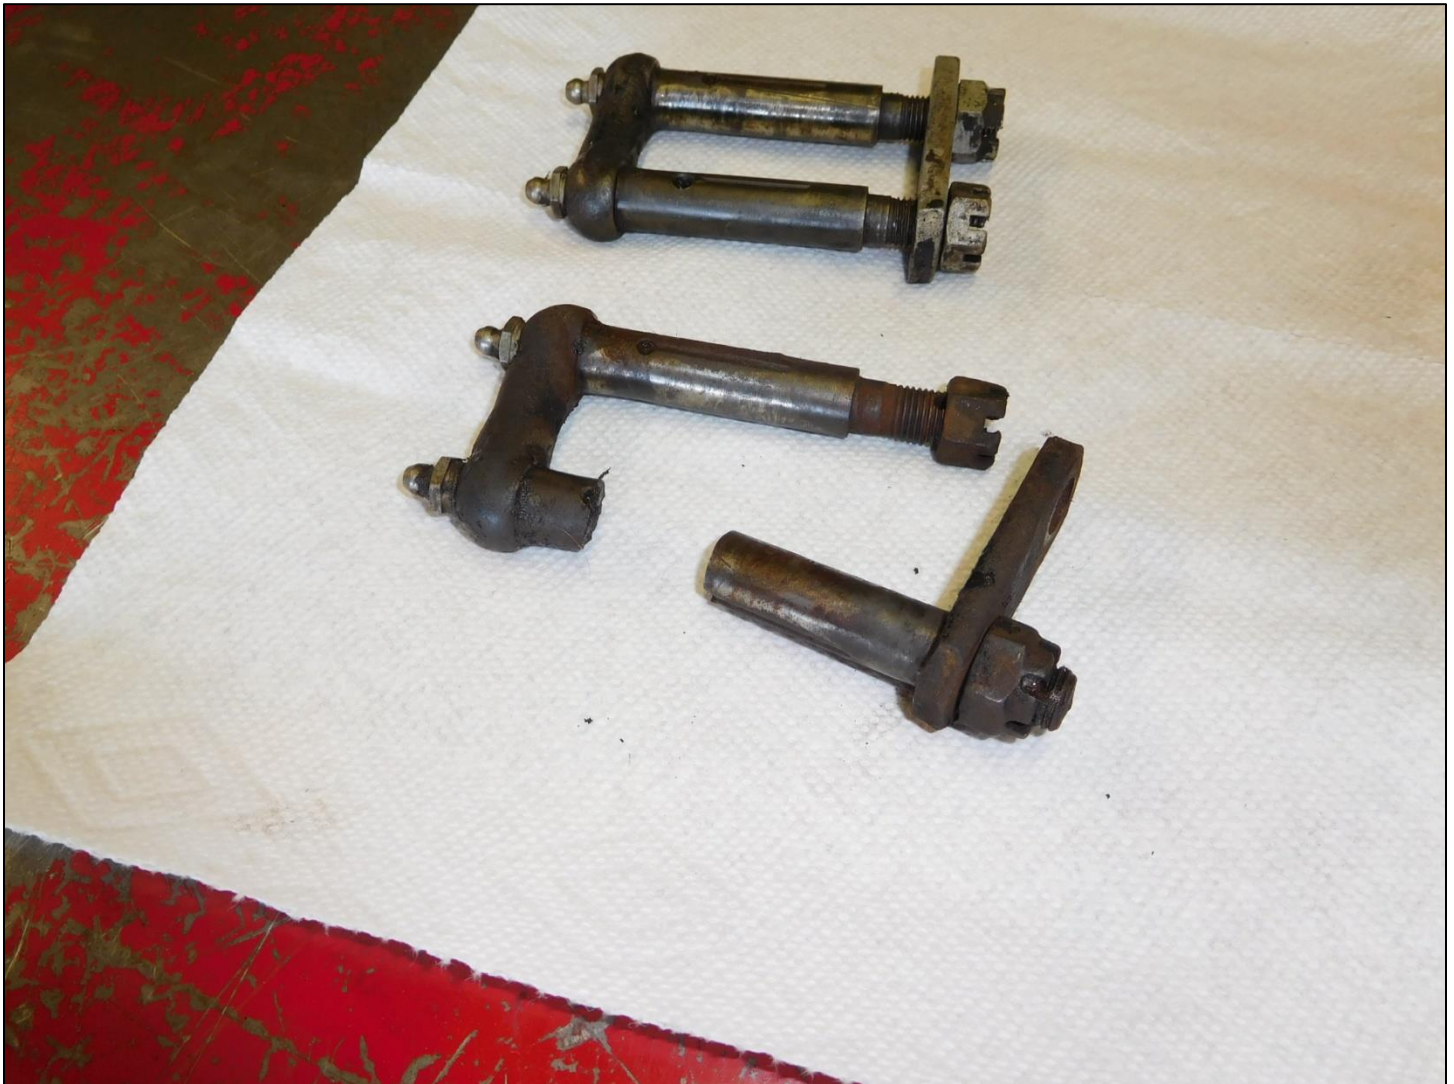
The left rear shackle was found broken while removing the rear axle assembly from my grandson's 1930 Tudor during restoration. This is why it is never a good idea to pull the rear end with the spring attached to it. The rear spring could have broken loose and flown in any direction once the spring was free from the frame.

A broken shackle bolt is usually caused by the bolt being overtightened. When installing shackle bolts, they should be pulled down tight to ensure they are fully seated, then backed off a turn to allow the bolts to freely rotate when the spring is flexed while traveling on the road. An overtightened bolt can shear as did this one.

The procedure we used to remove the rear axle assembly was to first capture the spring tension with a proper spring spreader. The shackles were then removed and the rear axle assembly dropped out. The spring spreader was then collapsed and removed. The spring was then safe to remove from the frame of the car for restoration.

A new set of rear shackles were installed during the restoration.
