Distributor Fault

by Tom Endy 2024

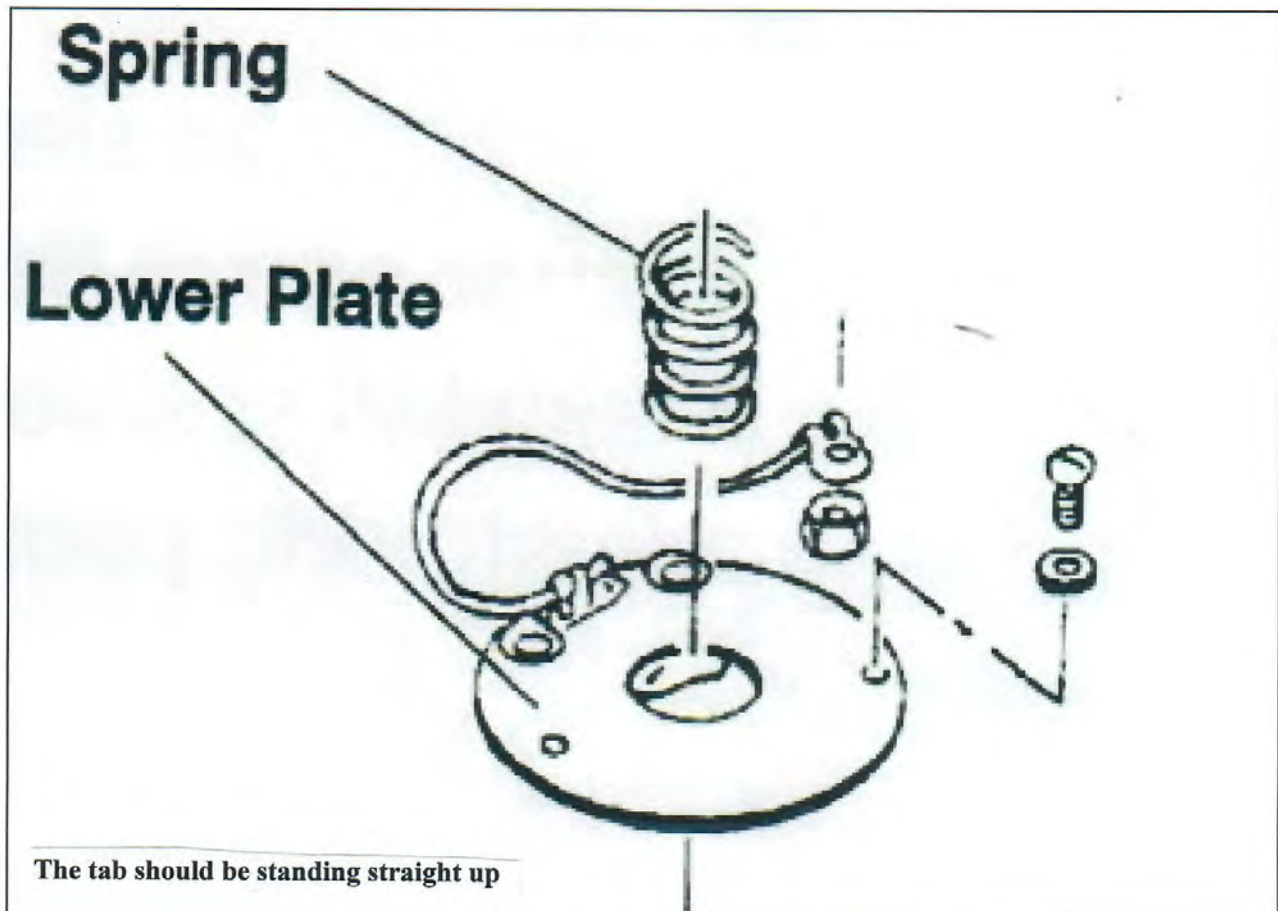
Very frustrating! I know a Model A distributor inside and out, what am I missing? A final inspection revealed the culprit. The tab on the lower plate the wire is attached to is supposed to be standing straight up. This one was leaning slightly out-board and was touching the casting....**almost**. An ohm meter did not indicate it was touching. A little bit of engine vibration trying to start the car, and it touched and shorted out. Bending it straight up cured the fault. It is currently working just fine on my Victoria.
